Towards Effective Storm Water Drainage and Management System in Yenagoa city, Bayelsa State, Nigeria

Ibama Brown, Tari Eyenghe

Department of Urban and Regional Planning in the Rivers State University, Port Harcourt, Nigeria

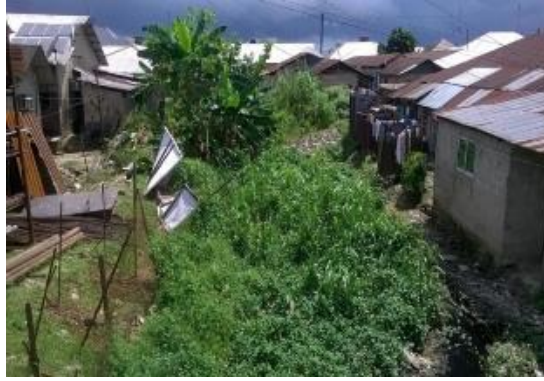
Plate 1: A section of a natural drainage system at Amarata Community up with Water Hyacinths and Wastes
Source: Researchers' Fieldwork, 2016

It was also observed that people develop properties close to the natural drainage paths without proper setbacks and narrowing these paths, and even to the wetlands intensifying the level of densification in the communities. The wetlands that are supposed to be conserved to serve its natural function of water retention as the available lands for development are reduced and limited see Plate 1.

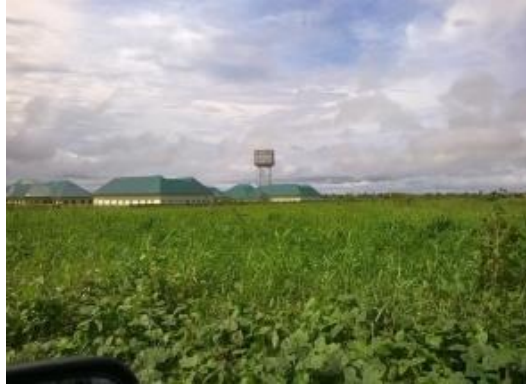
Plate 2: An Environmental Sensitive Area (Wetland) not properly Planned earmarked as Central Business District at Swali

The densification process is observed to be predominantly occupied by residential land use in the study area and some form of commercial developments such as retail outlets, banks, offices, petrol stations and other social facilities and services. Most of these commercial developments are located along the major arterials in the city. The area in the city zoned for Central Business District (CBD) has not been laid out for development, though, building development are on-going. Even most of the residential areas are not planned as evidenced in Plates 2 and 3.

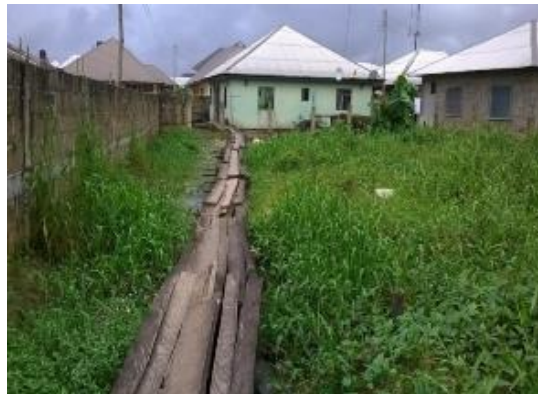
Plate 3: Unplanned Residential Neighbourhood within a Floodplain Area with a Wood Footpath "Monkey Bridge" to Access Buildings.

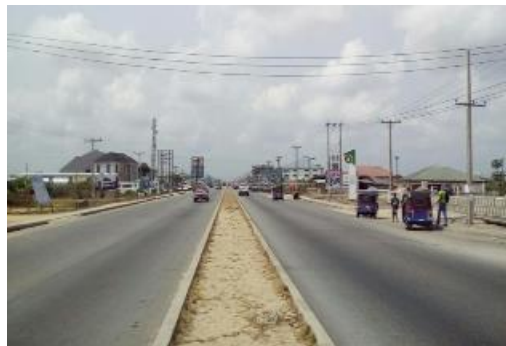
Plate 4: Isaac Adaka Boro Road one of the Major Road in the Study Area without Drainage
Source: Researcher's Fieldwork, 2016

Some properties are developed on identified wetlands in the study area with no approved building plans, adequate and functional drainage system (see Plates 4 and 5). And the existing drainages are not uniform in size (depth and width) across the study area and have effects on the flow and volume of storm water discharge.

It was also observed that all the major roads in the city do not have drainages for collection of storm water during and after precipitation especially on: Melford Okilo, Yenagoa-Mbiama, D.S.P. Alamieyeseigha, Isaac Adaka Boro and Swali-Imgbi Roads. These are the roads that connect various communities identified in the study area.

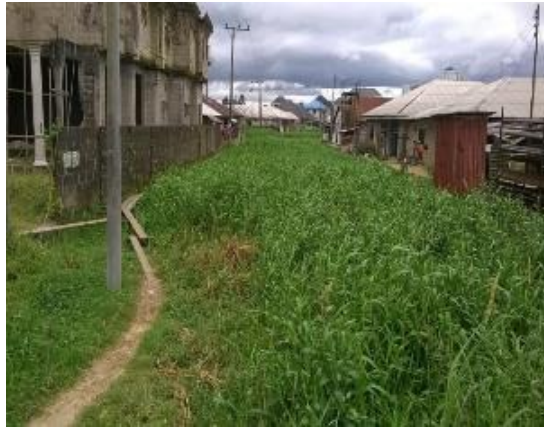
Plate 5: A Street in Biogbolo Community without drainage System overtaken by grasses
