## Brief Report of Shaking Table Test on Mud Mortar Stone Masonry House Strengthened with 2mm-Gabion Wire

**Abstract** During the April 25, 2015 Nepal earthquake, most of the houses that collapsed are mud mortar stone masonry houses. Therefore, a simple, affordable, replicable, and economical method is introduced to make such mud mortar stone masonry houses earthquake resistant. The method described in this report is based on the field observation during site visit on November 2015 and March 2016, i.e. using gabion wire mesh to strengthen the walls. Numerical analysis results and shaking table tests is discussed in this paper.

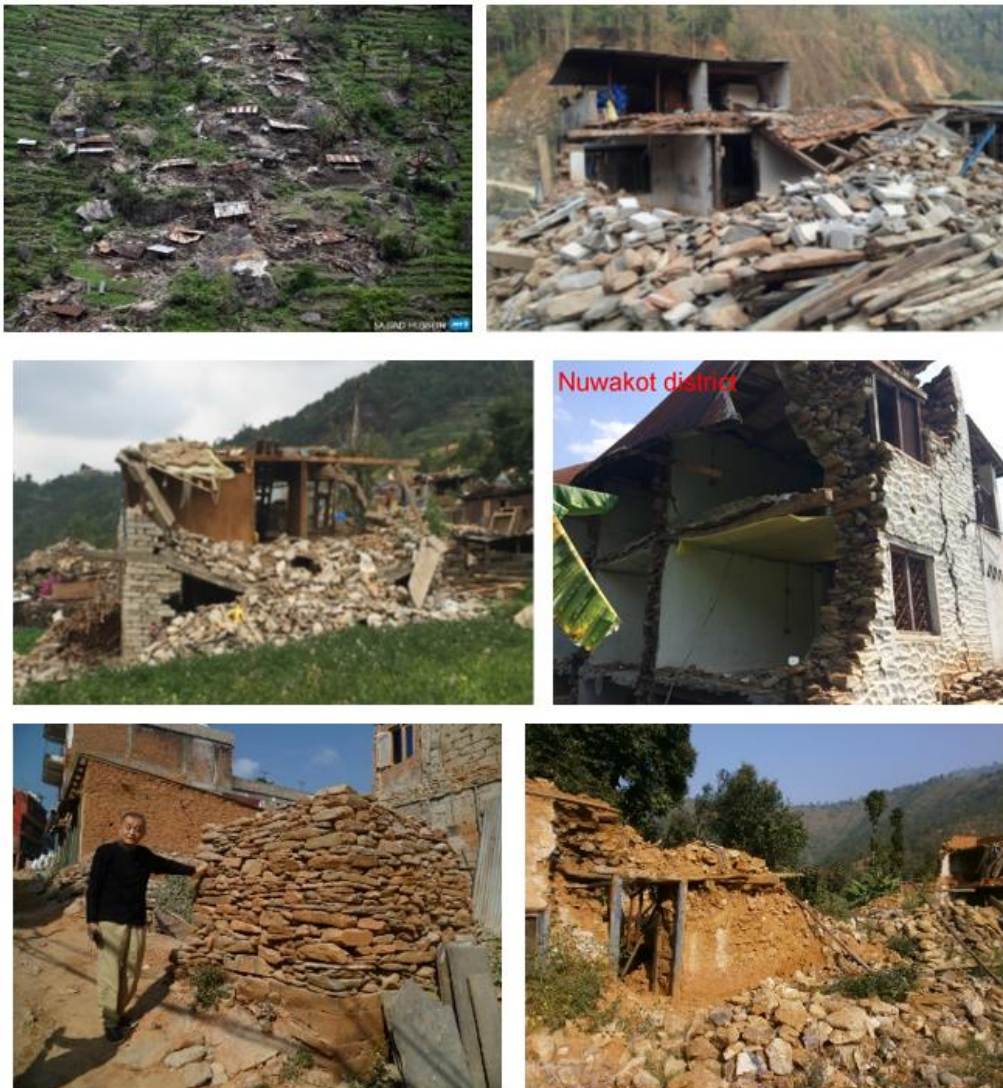
Figure 1: Mud mortar stone masonry houses collapsed due to April 25, 2015 earthquake

Nepal is one of the countries located in the Himalayan Belt with long history of destructive earthquakes. The typical house in mountainous areas in Nepal is mud mortar stone masonry as natural choice of the common people because stone is an abundant and easily available construction material compared to burnt clay bricks and concrete in these areas. In Nepal, there is a variety of stone masonry buildings, however, are fairly similar. During the April 25, 2015 earthquake, approximately 262,600 buildings were damaged, and 489,500 buildings collapsed [1]. Unfortunately, most of the buildings that collapsed are non-engineered buildings, i.e. mud mortar stone/brick masonry houses (

Figure 1). According to the Nepal Building Code for Earthen Buildings [2], the building shall be single-story in height plus an additional attic floor with floor to floor height shall not be less than 1.8 m and not greater than 2.5 m. The thickness of wall should be tapered with 600 mm at bottom and 450 mm at the top. For earthquake resistant design, NBC 204:1994 stated that bamboo or timber vertical reinforcement and horizontal bands (at plinth, sill and lintel levels of the building) shall be constructed. However, in actuality, not many houses follow the NBC (Figure 2). If the horizontal bands are replaced using reinforced concrete bands, the performance of stone masonry houses during earthquakes will improve. However, cement in Nepal is quite expensive and is not easy to obtain by the people living in mountainous regions. Therefore, to make mud mortar stone masonry houses earthquake resistant, a simple, affordable, replicable, and economical method should be found. The method must also be familiar to local masons.

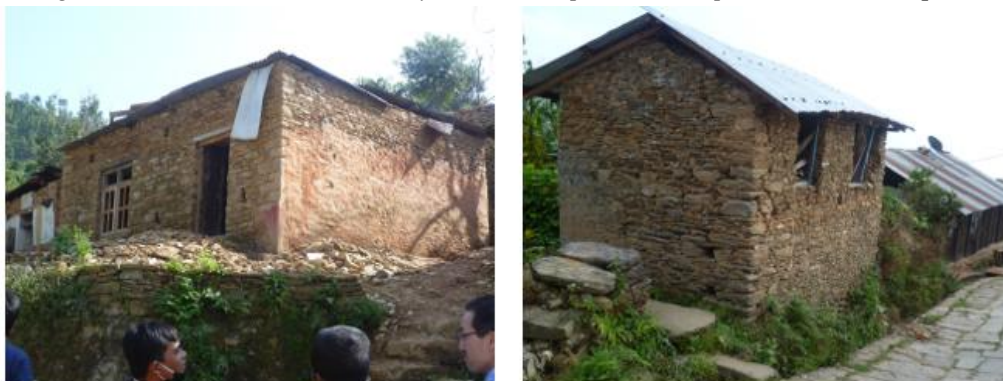
Figure 2: Mud mortar stone masonry houses without horizontal bands

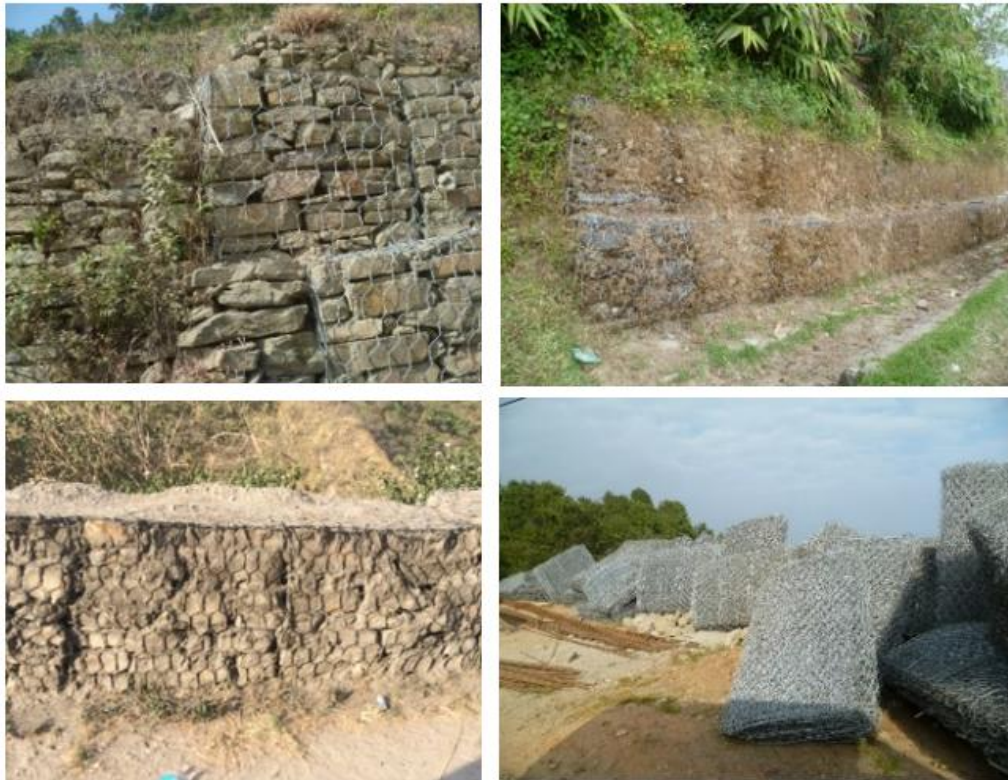
*Figure 3: Gabion is used as retaining walls*

When the first author visited Nepal in November 2015 and March 2016, the first and second authors observed that many gabions along the winding roads in the mountainous regions that were utilized as retaining walls and almost all gabions were still intact and not damaged (Figure 3).

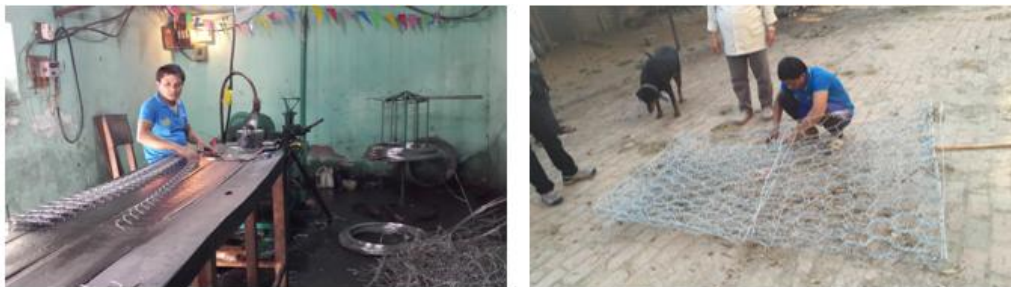
*Figure 4: Gabion wire mesh produced in Nepal*

The gabion wire mesh is produced in Nepal and can be found easily (Figure 4). Hence, the gabion wire mesh can be used to strengthen the mud mortar stone masonry houses by covering all inner side and outer side of the walls. The inside and outside gabion wire mesh should be tied by 2mm wires as close as possible, approximately at a distance of 30cm. The aim of the ties is to ensure that the inside and outside gabion wire mesh work together to resist the earthquake forces and to provide “bonding” between the stone masonry wall and the wire mesh. The wire mesh used is diameter 2mm, smaller than the common gabion wire mesh which is usually larger than 3mm. Besides gabion wire mesh, rectangular welded wire mesh can also be used for strengthening walls.

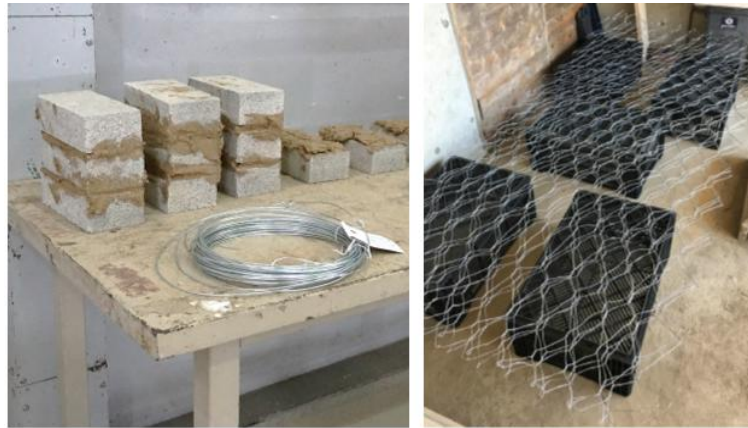
Figure 7: Materials used to construct mud mortar stone masonry

Since stone is not a common material to build houses in Japan, the stone material is specially made using cement mortar with the similar characteristics as the stones in Nepal. The size of one stone is 210x100x60mm, with weight 2.5kg. The essential materials to construct the models e.g. stone, 2-mm gabion wire mesh with spacing 100x150mm, and tie wires (Figure 7). The gabion wire mesh produced manually by the second author

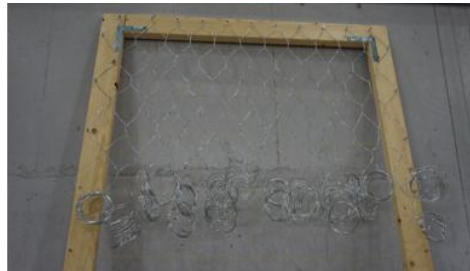
Figure 8: The gabion wire mesh produced manually by the second author

(Figure 8). Figure 9 shows the construction of mud mortar stone masonry houses wrapped with gabion wire mesh.

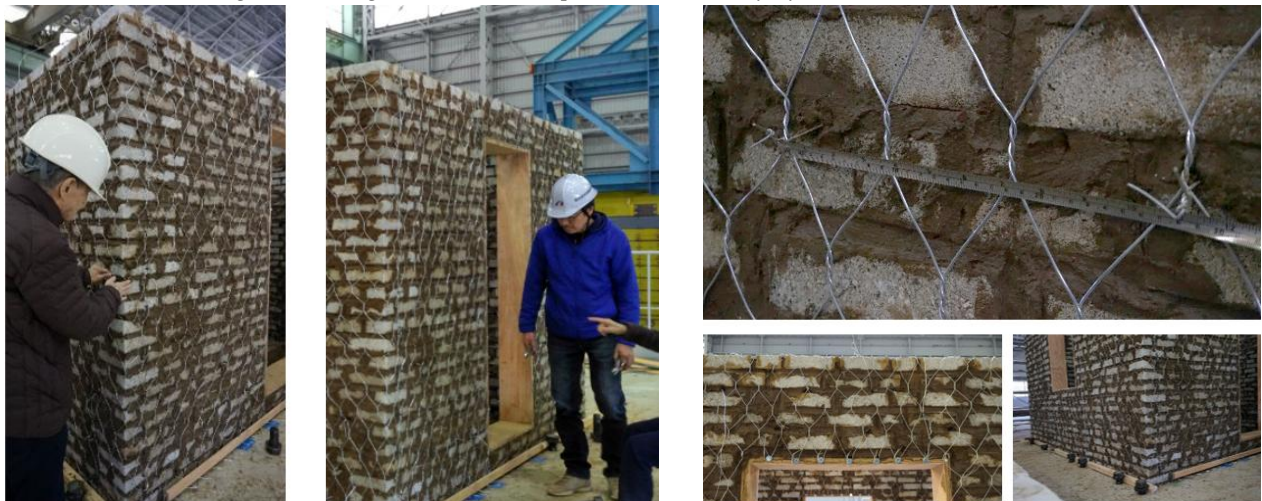
Figure 9: Construction of mud mortar stone masonry houses wrapped with gabion wire mesh.

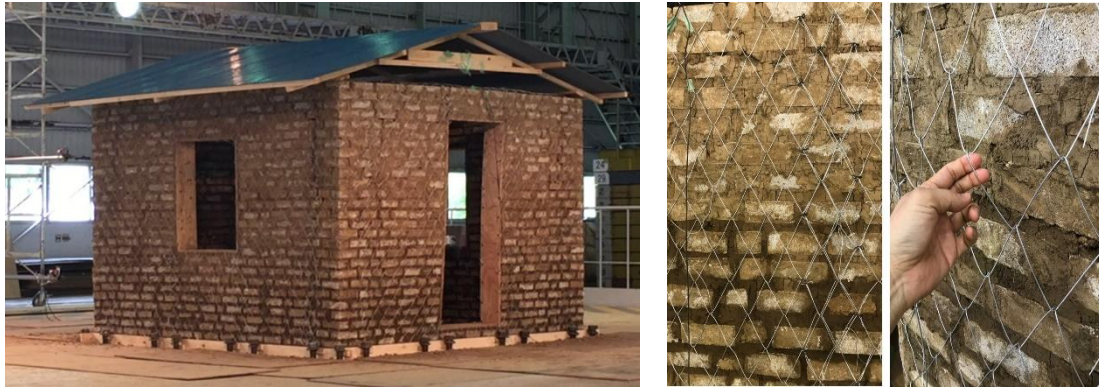
Figure 10: Model B, mud mortar stone masonry strengthened by wrapping 2mm commercial type gabion wire mesh on both sides of the walls, constructed at the end of May 2019

At the end of May 2019, same Model B, unreinforced mud mortar stone masonry strengthened by wrapping 2mm gabion wire mesh on both sides of the walls, was constructed again. However, the gabion wire mesh was different than the February 2019 model. The wire mesh used is the commercially available gabion wire mesh. (see Figure 10). This shaking table test was conducted to make sure that commercial type gabion wire mesh also can be used to strengthen the mud mortar stone masonry.

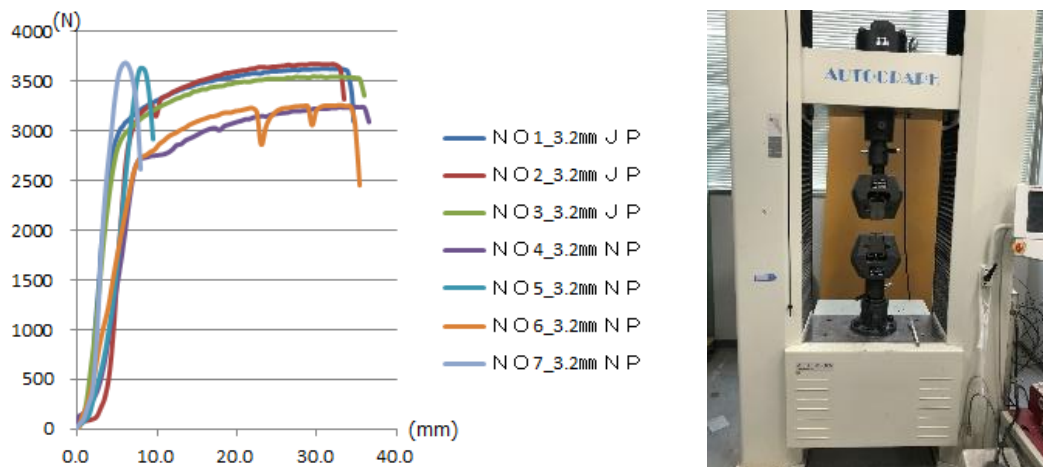
Figure 11: Tensile test of 3.2mm gabion wire mesh: the results (left) and the experiment tool (right)

1. Mud mortar stone masonry wall:
  - a. Modulus elasticity = 300 MPa
  - b. Tensile strength = 0.056 MPa
2. Gabion wire mesh:
  - a. Modulus elasticity = 69,000 MPa
  - b. Tensile strength = 435 MPa
3. Gabion wall (stone and wire mesh):
  - a. Modulus elasticity = 1.47 MPa [3]

The tensile strength of gabion wire mesh is obtained from the tensile test of 3.2mm gabion wire mesh (Figure 11)

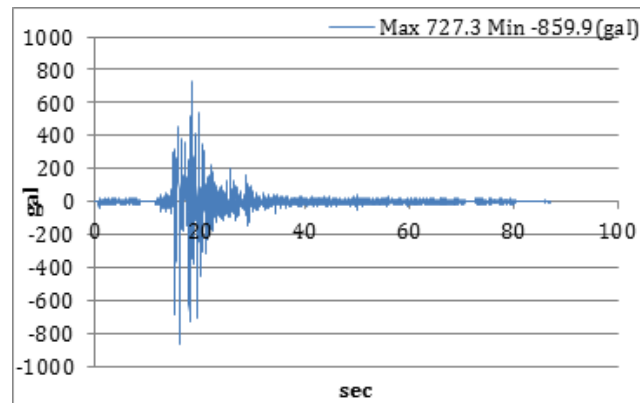
Figure 12: Input motion of JMAKobe NS

The shaking table was a horizontal uniaxial movement type. JMA Kobe NS earthquake records (Figure 12) was used as input motions for this test. The excitation increased gradually as follows:

- a. JMA Kobe (10%)
- b. JMA Kobe (20%)
- c. JMA Kobe (30%)
- d. JMA Kobe (50%)
- e. JMA Kobe (70%)
- f. JMA Kobe (100%)

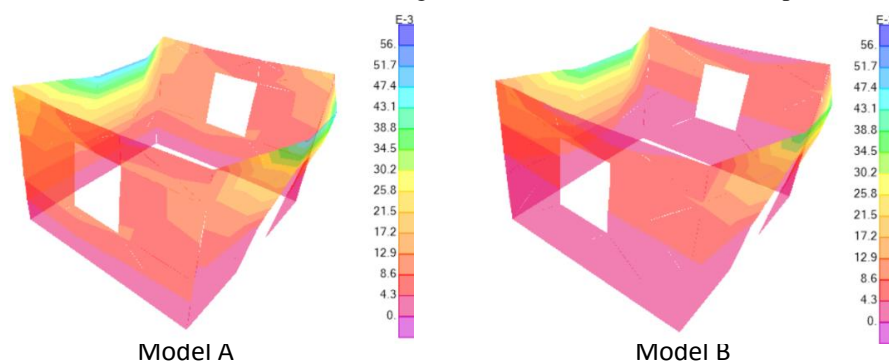
■ indicates the maximum tensile stress exceeded, meaning substantial cracks start to develop in walls.

Figure 13: Maximum tensile stress pattern in stone wall due to 30% JMA Kobe; no stress exceeded

The analysis is elastic-linear-time-history and utilizing commercial softwares. Material properties used for this model are as described in Section 0. For the analyses of 30% JMA Kobe and 50% JMA Kobe, the damping is 5% and the strengthened mud mortar stone masonry walls are modeled using sandwich analogy. From the damage observation after the April 25, 2015 earthquake, most of the mud mortar stone masonry houses that collapsed became a pile of stones since after being shaken by a 0.8–1.0g earthquake in much of the affected districts (1.0–1.2g in some parts of Sindhupalchok district) [4], it seemed that there is no more bonding between mud mortar and stones (see Figure 1). Therefore, for the analysis, it is assumed that after being shaken by JMA Kobe 50% (approximately 0.4g), the mud mortar stone masonry walls behave like gabions. Based on the above facts, for the analyses for 70% JMA Kobe and 100% JMA Kobe, the modulus elasticity of walls is assumed to be approximately 1.47 MPa [3]. The analyses are assumed as gabion walls and the damping for analyses of 70% JMA Kobe is 10% and for 100% JMA Kobe is 15%. The maximum deformation of the West wall for JMA Kobe 70% is approximately 34.45cm and for the JMA Kobe 100%, the maximum deformation of the West wall is approximately 42.07cm (Figure 16).

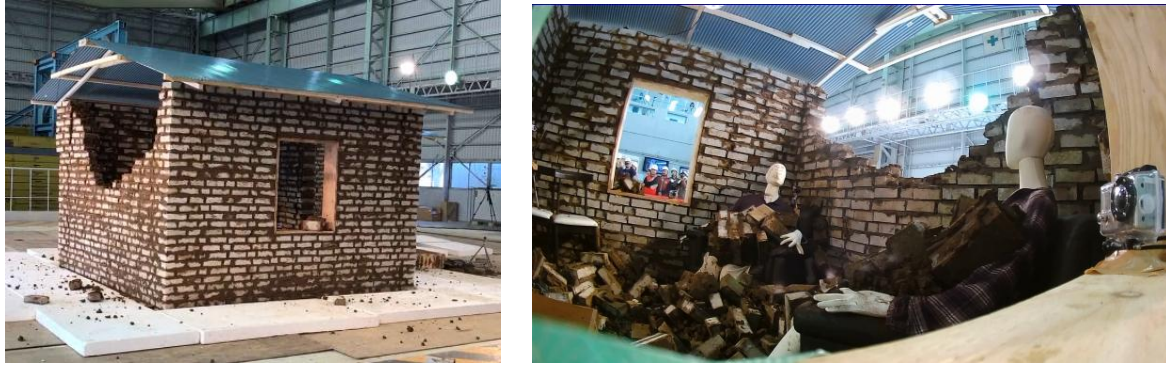
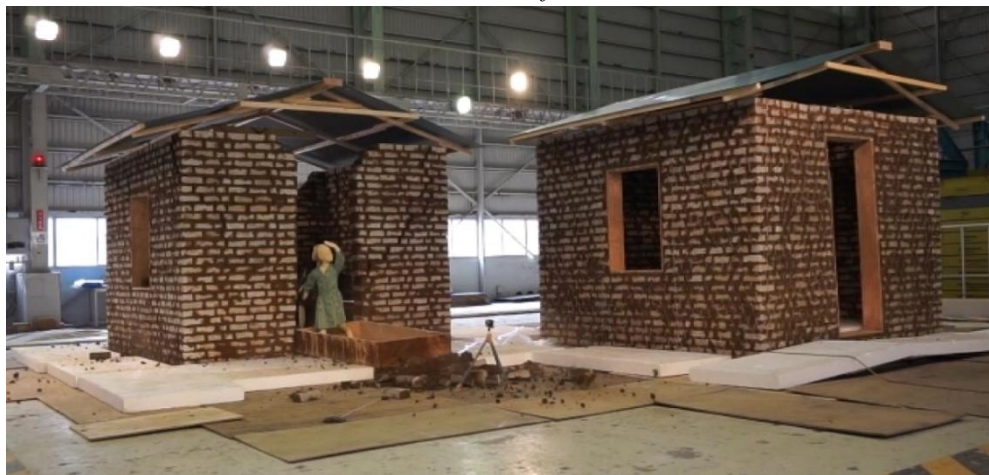
*West wall Model A from outside (left) and from inside (right)*

*West wall Model B from inside*

*Model A (left) collapsed; Model B (right) survived*

*Figure 17: February 26, 2019 shaking table test: Model A collapsed due to 50% JMA Kobe; Model B survived*

Both models survived when shaken by 10% JMA Kobe and also 20% JMA Kobe. There were no significant cracks or damage. When shaken by 30% JMA Kobe, the West wall (without opening) and the East wall (door opening) of Model A (original unreinforced mud mortar stone masonry) deformed at the top of walls but did not collapse. Significant damage for Model A occurred at 50% JMA Kobe. Both West and East walls collapsed at the top of walls. Meanwhile, for the same input motion level, Model B, the structure strengthened by wrapping 2mm gabion wire mesh on both sides of the walls, did not show any significant damage although the walls deformed [5].

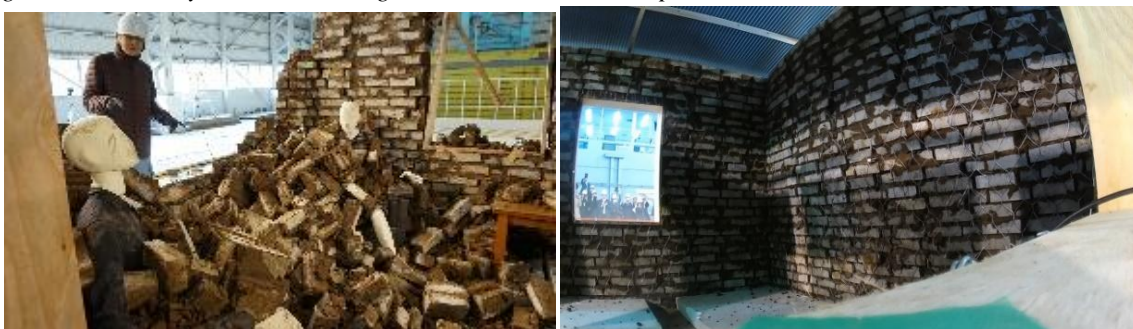
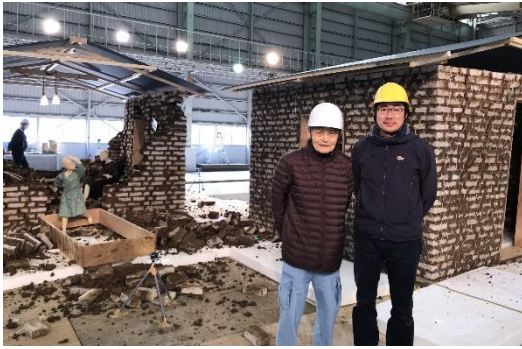
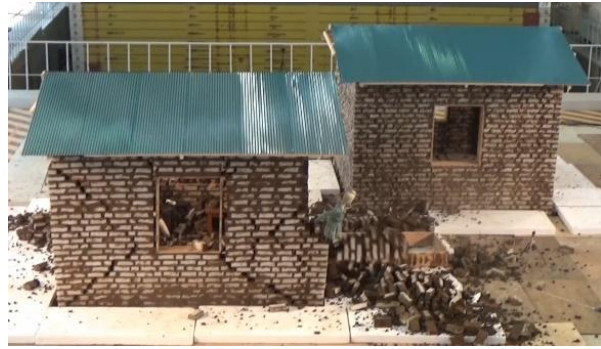
*Model A: West and East walls collapsed due to out-of-plane loading; large cracks from window openings in North and South walls*

Figure 18: February 26, 2019 shaking table test: Model A collapsed & Model B still standing due to 70% JMA Kobe

The input motion was increased to 70% JMA Kobe. All of the West and East walls in Model A collapsed due to out-of-plane loading and almost at the same time large cracks from window openings in North and South walls occurred. Model B still survived although the West wall deformed [6]. The input motion of 100% JMA Kobe conducted for Model B only on June 4, 2019 test, showed substantial cracking and deformations of the West and East walls, however, did not collapse (Figure 17 & Figure 18). Therefore, the gabion wire mesh on both sides of the walls served the purpose to save human lives. From Figure 18, it can be seen that the deformation for Model B for 100% JMA Kobe in West wall is approximately 45 cm and in East wall is approximately 29 cm. Those figures are in the same range as the analysis (see Figure 16).

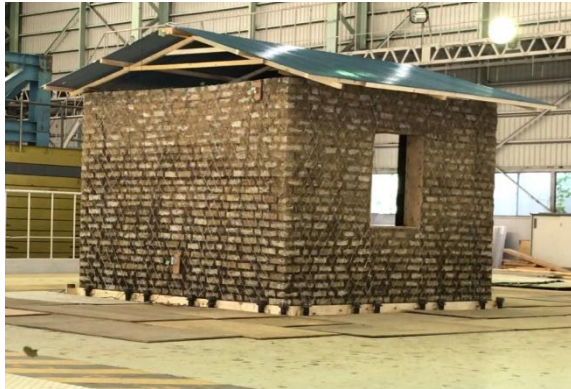
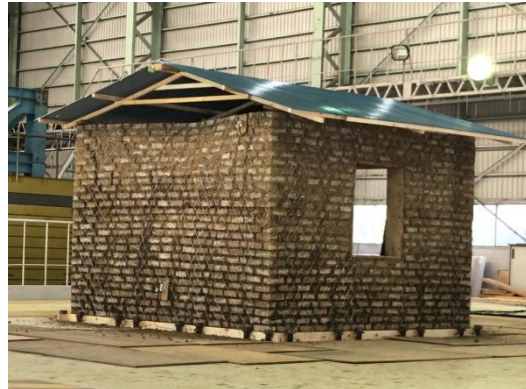
Figure 17: June 4, 2019 shaking table test with 50% JMA Kobe (left) and 70% JMA Kobe (right) input motion for Model B only

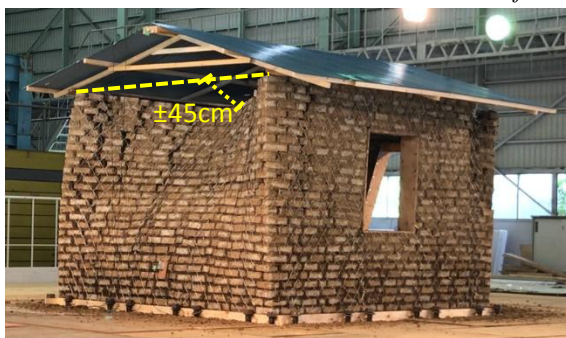
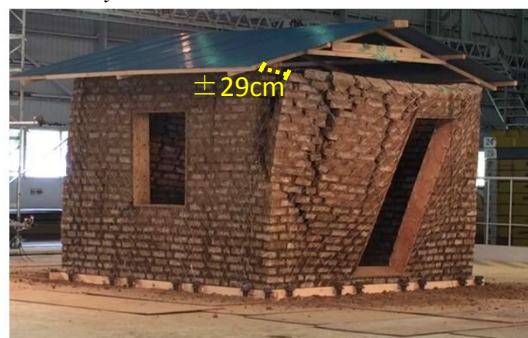
West Wall

East Wall

Figure 18: June 4, 2019 shaking table test with 100% JMA Kobe input motion for Model B only: substantial cracking and deformations but did not collapse
