## Investigation on the Actual Behaviour of a Reinforced Concrete Beam Occasioned by Abandonment

**Abstract** This paper presents the results of an investigation into the actual behavior of a two-layer reinforced concrete beam occasioned by abandonment. Six (6) RC beams of 1100 x 100 x 150 mm, provided with 2 $\phi$ 10 and 2 $\phi$ 8 at the bottom and top, respectively, and  $\phi$ 6 mm at 225 mm spacing, were used as links. The beams were constructed with a 1:2:4 mix ratio and a 0.54 water-to-cement ratio. Two beams were used as control and were constructed with a single concrete layer, while the remaining beams were produced to different depths and abandoned for 28 days before being completed. All beam specimens were statically loaded on a 20-ton capacity loading frame to assess load-carrying capacity and resistance to deformation under applied load. The results show that abandonment has no adverse effect on the general performance of reinforced concrete beams. The abandoned concrete at the bottom fiber of the reinforced concrete beam contributes significantly to the general performance of the reinforced concrete beam. The abandoned reinforced concrete beams with an initial aban

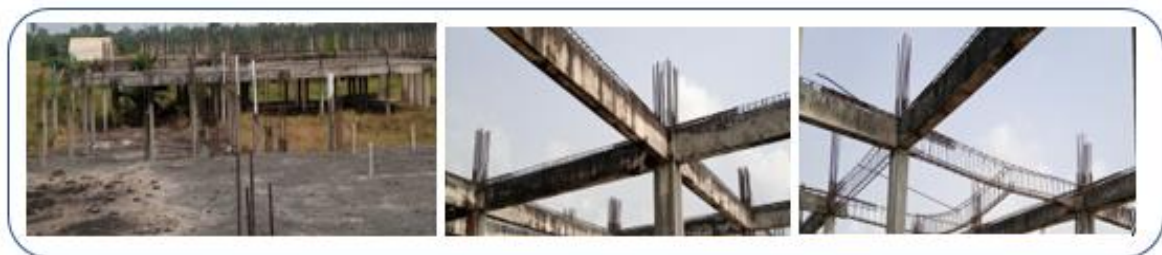
Figure 1: Abandoned RC members

Construction project abandonment as shown in Figure 1 is a menace that has plagued the construction industry in Nigeria. With all the states suffering from construction project abandonment, there is a need to understand the structural implication of abandonment on structural members. However, several studies have been done relating to construction project abandonment and its social and economic effects, including environmental effects [17, 18]. However, the actual structural response of a reinforced concrete (RC) beam caused by abandonment has not been thoroughly investigated. It is in this view that the research was carried out to assess the actual structural response of an RC beam occasioned by abandonment by using a model in the laboratory.

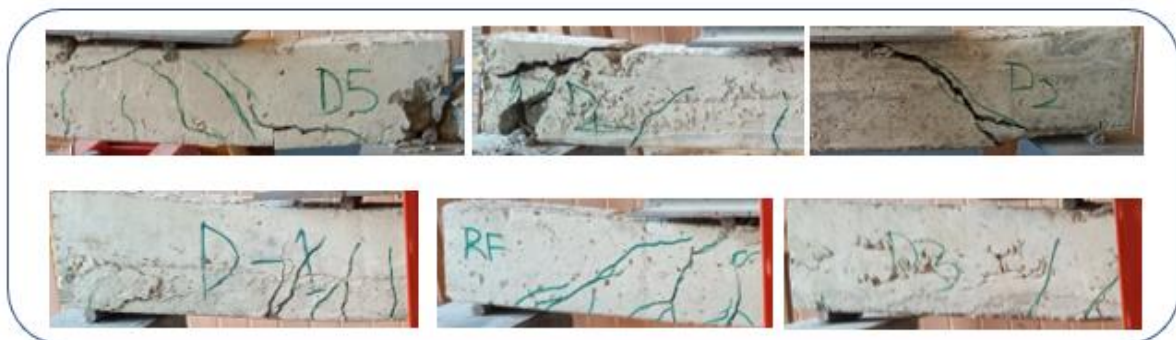
Figure 5: Crack pattern
