Application of Digitized Topography Information to Curb the Menace of Flooding and Its Health Implications at Ogbia Local Government Area

Abstract This research was carried out with the aim of using digitized topography information to study the natural drainage pattern that will in the long run assist in the design of a workable drainage system. The research was engendered by the incessant flood experience by Bayelsa state on a yearly basis and the urge to curb the menace imposed by the flood. To achieve this objective, 498 sampled coordinate points along with their elevations were extracted from an image map. The coordinates and the topography information were developed into contour maps, which depict the distribution of topographic information within the area under investigation. The analyzed results have revealed that the topographic distribution of the elevations within the landmass is very heterogeneous with no definite regional pattern. Hence, it is difficult to tie or delineate the direction of the natural drainage pattern to the existing topographic structure. However, detail studies have revealed that the natural drainage systems are majorly directed south west and south

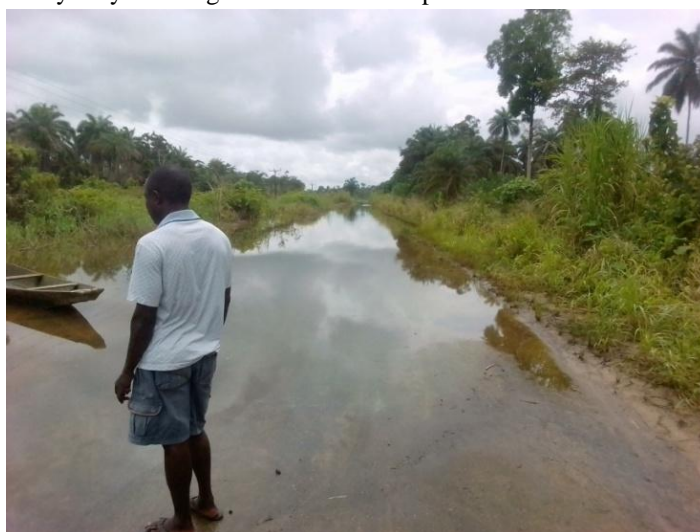
Figure 1: Road leading to Federal University Otuoke completely submerge under water

The coordinate data within figure 1 and 8 regions were also contoured, as shown in figure 15. It shows that the road is located in a region with moderately high elevation surrounded by large water bodies. However, the image map and contoured map has shown that the road is susceptible to flooding once there is an overflow from the surrounding major Onuebu River in addition to the contribution of the smaller river that runs across it. It is suggested that to avert the flood that usually occupy the road, the channel of the river that runs across the road should be well dredged, in addition a major embankment of about 5 km should be built along part of the major Onuebu River to curtail the overflow. The road should also be raised with a culvert under to allow free movement of surface water.

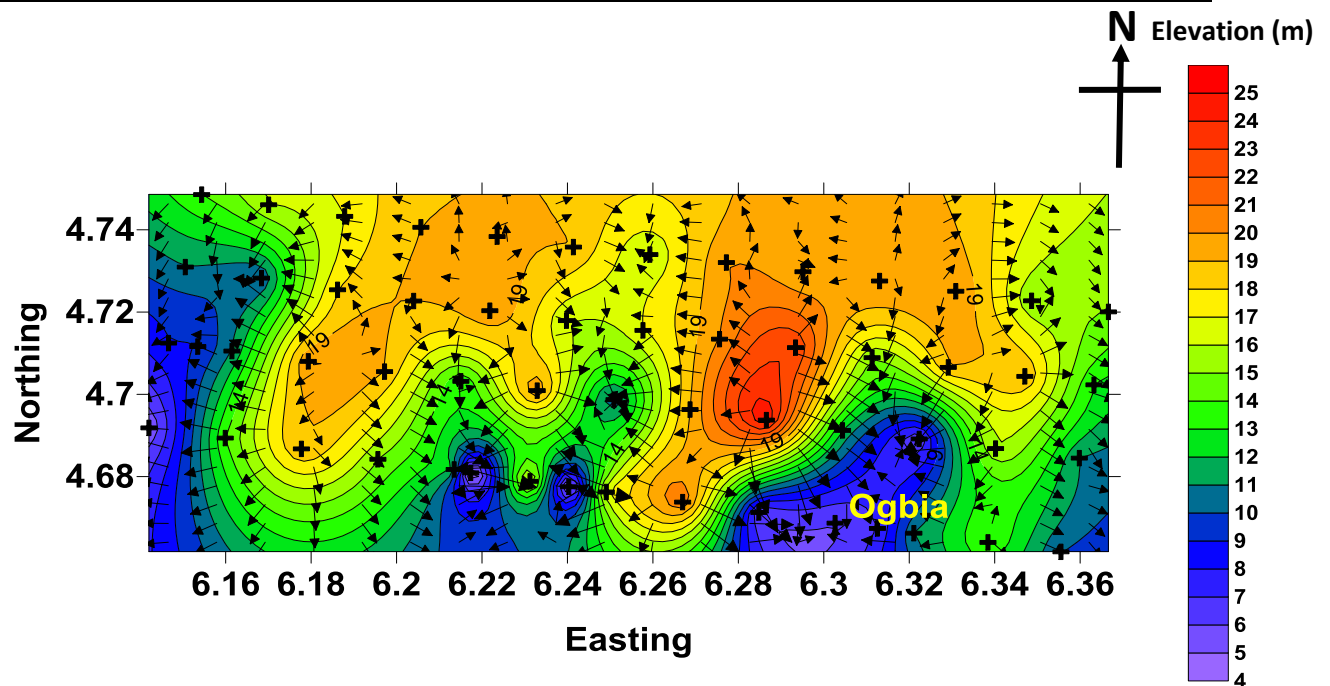
Figure 17: Contoured Map of Ogbia Town

A closer examination of the image maps of figure 5 to 10 and 16, and the contoured map of figure 14 to 17 gave a clear indication that Bayelsa settlements are linearly cling to major water bodies, avoiding the elevated high lands surrounding the major water bodies. These styles of settlements have made most structure in Bayelsa to be prone to flood. The houses are built along flood plain with an average elevation of 8 m above mean sea level, while behind those structures are landmass with an average elevation of 26 m above mean sea level. It is recommended that future development should be directed toward the high lands, than clinging to low land surfaces prone to flood.
