Journal of Scientific and Engineering Research, 2025, 12(4):133-139

Strength Characteristics of Concrete Produce with Partial Replacement of Cement with Calcined Halloysite

Afeez K. Oyelami, Oluwole A. Olaniyi*

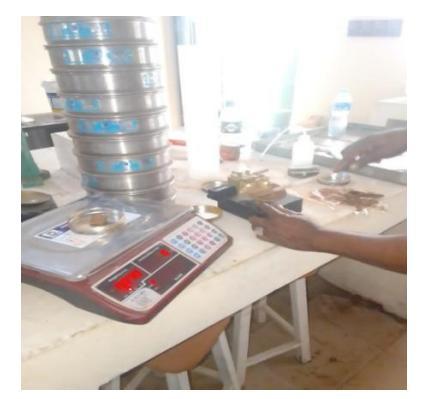
Figure 1: Sieve Analysis on calcined halloysite (CH)

The calcined halloysite (CH) was collected and weighed before being ground into finer particles using a milling machine. The ground material was then sieved to ensure uniform particle size. Sieve analysis was conducted manually in the Soil Mechanics Laboratory at the Civil Engineering Department, Ajayi Crowther University oyo, oyo state as shown in figure 1, using a set of sieves with a 1.4µm diameter. The sieved sample was weighed, and the particle size distribution was determined. A grading curve was then plotted to analyze the particle size characteristics.

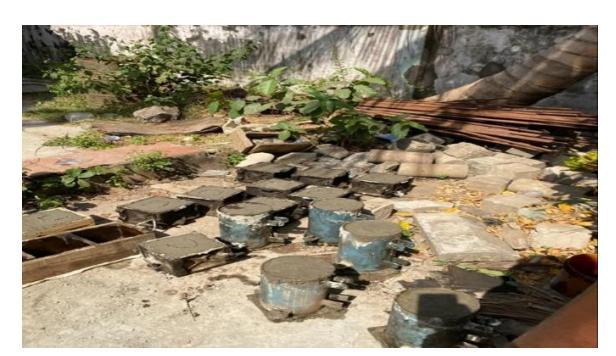
Figure 2: Cube samples

The mix ratio used for the concrete was 1:2:4, with a water-cement ratio of 0.60 to achieve the desired compressive strength. Cubic samples of $150 \times 150 \times 150$ mm³ were cast to evaluate compressive strength as shown in figure 2, after curing for 7, 14, 21, and 28 days. After curing, the concrete cubes were removed from the water tank and allowed to rest for 45 minutes before undergoing compression testing. To ensure uniform distribution while placing the mixed concrete into the moulds, a scoop was moved around the mould's edges. Each layer was compacted with 35 strokes using a tamping rod, and the surface was leveled with a trowel. The samples remained in the moulds for 24 hours, after which they were demoulded and submerged in water for proper hydration at 7, 14, 21, and 28 days. Additionally, concrete cubes of the same size were prepared for the water absorption test.

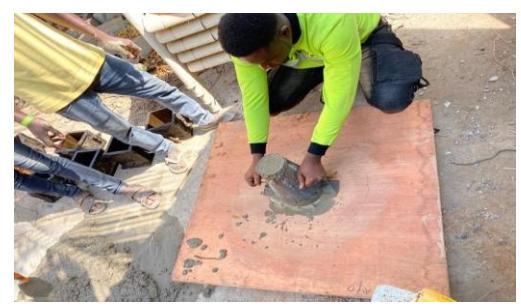
Figure 3: Slump Test

Slump test was carried out using the slump cone 300mm high as shown in figure 3. The cone was placed on a smooth horizontal surface with the smaller opening at the top. The concrete were poured in three layers; each layer was tamped 35 times with standard steel rod of 16mm diameter. Immediately after filling, the cone was lifted and the decrease in the height of the slump was measured and recorded.

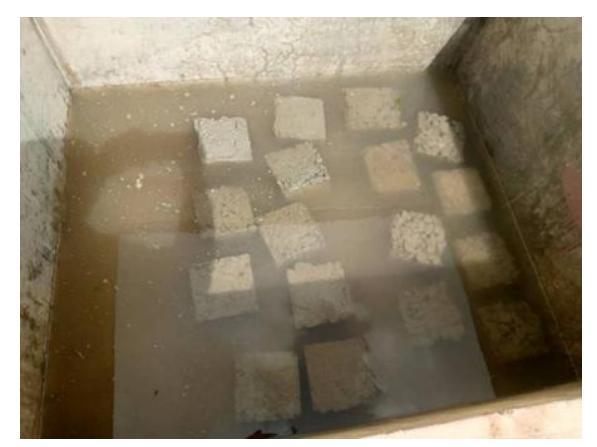
Figure 4: Cube Curing

This test was conducted on concrete samples to determine the rate of water absorption. The samples were initially immersed in a curing tank for 25 days. As shown in Figure 4, the cubes were submerged in water for curing. After this period, the samples were removed and left to dry for 48 hours, then re-immersed in water for an additional 2 days. The weight of the concrete was measured after 28 days of curing and again after the additional 2-day curing period. The difference in weight represents the water absorption rate.

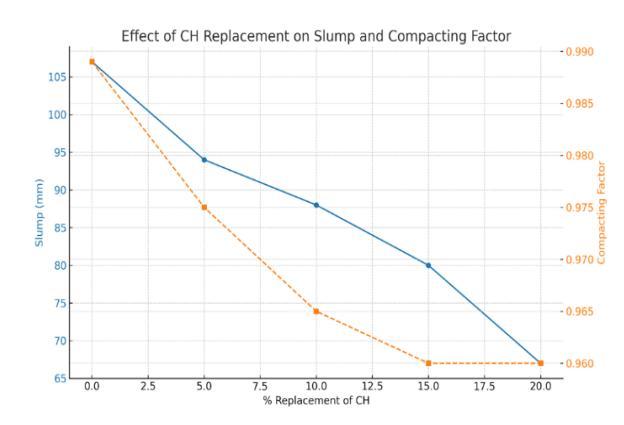
Figure 5: the effect of CH replacement on Slump and Compacting Factor

The slump value declines from 107 mm to 67 mm as the proportion of CH increases. Likewise, the compacting factor decreases from 0.989 to 0.960 with higher CH content. These results indicate that increasing CH content reduces the workability of concrete, suggesting that more water is required to maintain the desired consistency. Figure 5 shows a graphical representation:

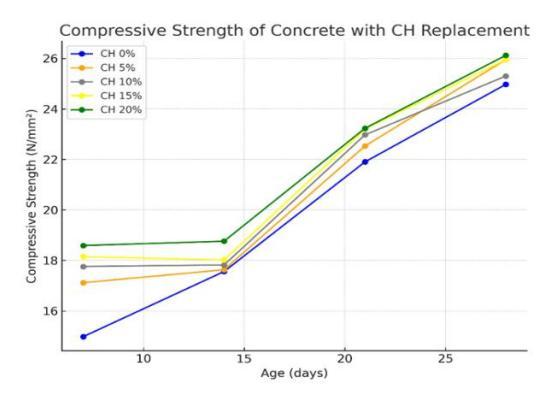
Figure 6: Compressive Strength of Concrete

Furthermore, Figure 6 shows the results that compressive strength generally increases with the curing period but decreases as the CH replacement increases. At 7 days, the strength increased from 14.98 N/mm² to 18.59 N/mm² at 20% CH replacement. A similar trend was observed at 14, 21, and 28 days. These findings indicate that concrete containing CH gains strength more slowly at an early curing age.
